# Manhole Inspection Summary

Manhole # S21W\_\_020MH

**Location** Address: **2200 BERLIN ST**

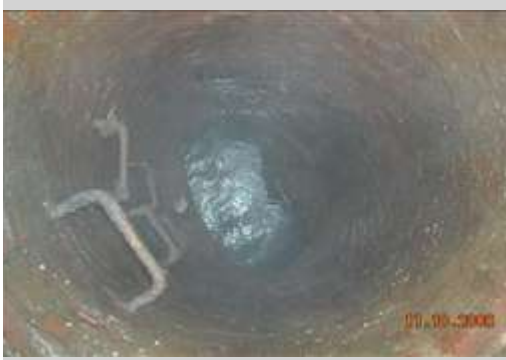
Defect

**Steps** Count: **6** Missing: **0** ☒ Corroded

corroded steps

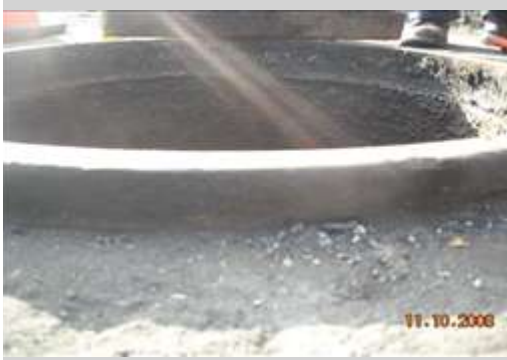
Defect 3

**Cover** Shape: **Circular** Diameter: **24** (in.) Length: **0** (in.) Dist A/B Grade: **1** (in.)

FRAME ABOVE GRADE

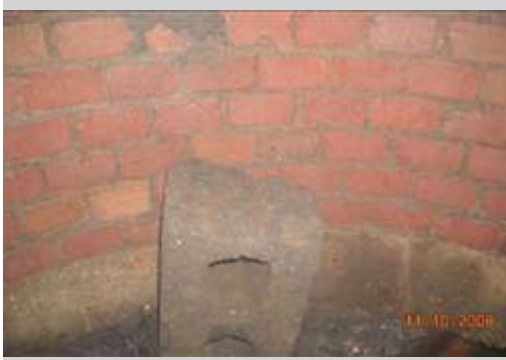
Defect 2

Condition: ☐ Sound ☐ Cracked ☐ Root Intrusion ☐ Deteriorated ☐ Leaks ☒ Debris

DEBRIS ON BENCH

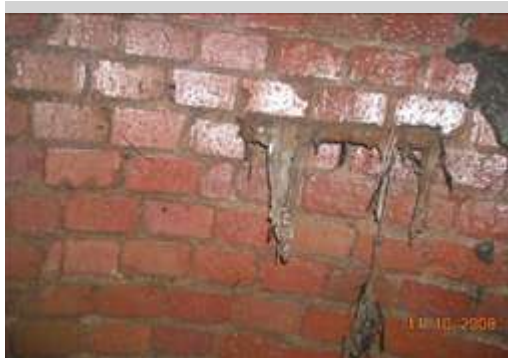
### Defect 1

**Surcharge** ☒ Evidence Of Surcharge Depth: **4** (ft.) ☐ Active Surcharge Present

SURCHARGE EVIDENCE

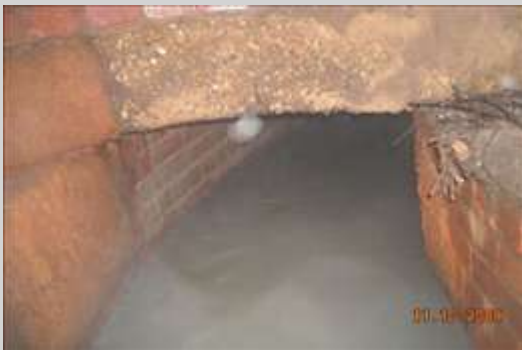
12 O'Clock Outflow

24 in. Circular Gravity Sewer  
Pipe Out @ 12 O'Clock

Pipe Height: **24** (in.) Rod and Bar (Angled)  
Pipe Material: **Unknown** ☐ Pipe Lined  
Invert Depth: **13.10** (ft.) Flow Characteristics: **Fast**  
Deposits: ☒ None ☐ Mud ☐ Sludge ☐ Debris ☐ Grease  
Silt Depth: **0** (in.) Deposits Extent:  
Infiltration: **None** Pipe Seal Cond: **Sound**

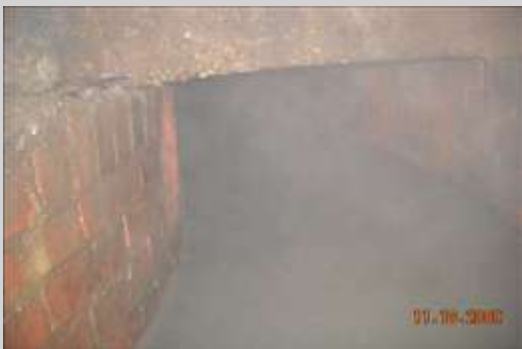
5 O'Clock Inflow

24 in. Circular Gravity Sewer  
Pipe In @ 5 O'Clock

Pipe Height: **24** (in.) Rod and Bar (Angled)  
Pipe Material: **Unknown** ☐ Pipe Lined  
Invert Depth: **12.93** (ft.) Flow Characteristics: **Fast**  
Deposits: ☒ None ☐ Mud ☐ Sludge ☐ Debris ☐ Grease  
Silt Depth: **0** (in.) Deposits Extent:  
Infiltration: **None** Pipe Seal Cond: **Sound**
